# CASE HISTORY

## Restoration And Protection Of Concrete Pipelines

Tarragona, Spain

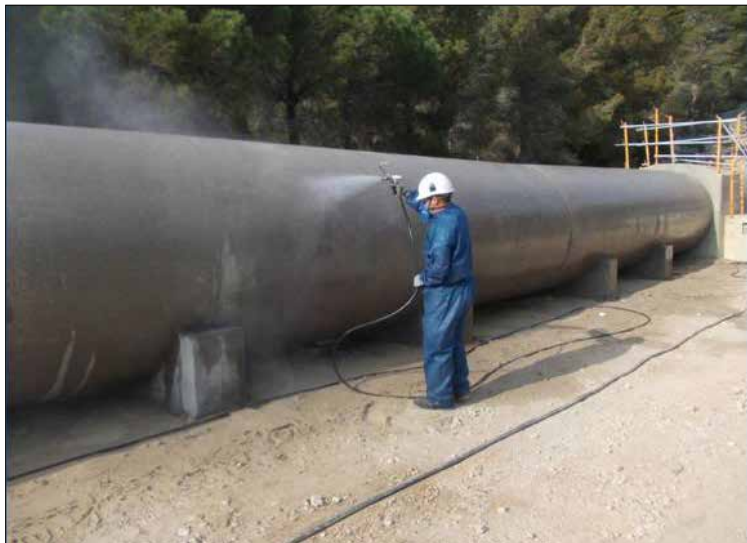
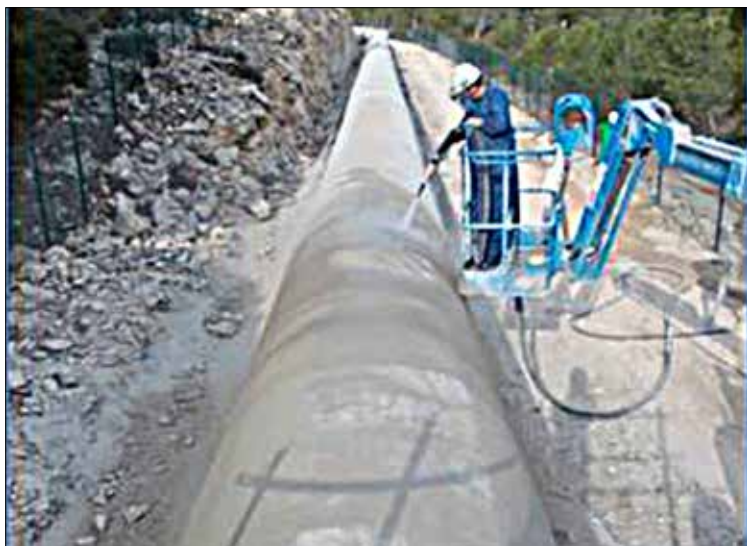
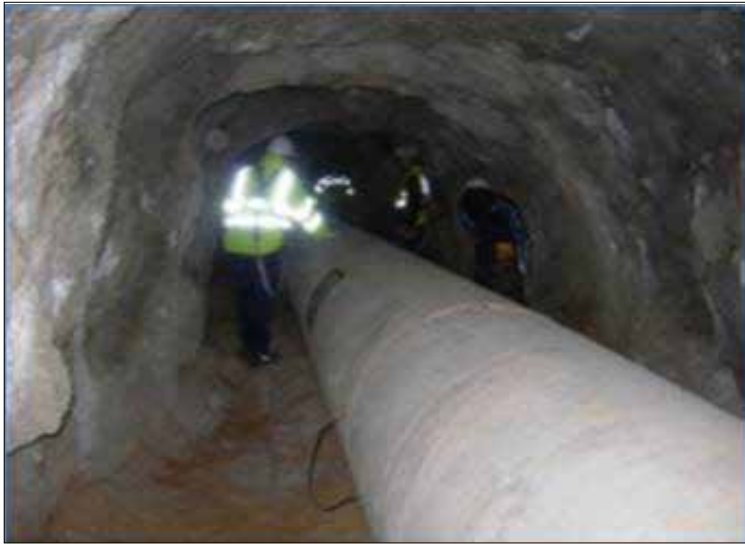
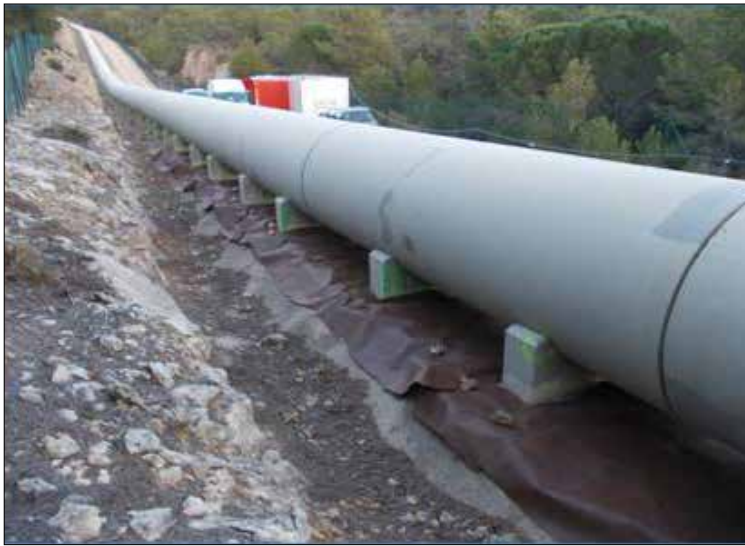
C.A.T.'s network of pipes are composed of prefabricated reinforced concrete. After 30 years, corrosion problems were detected in different areas of their 13.300 m<sup>2</sup> pipeline system.

The damaged concrete and rust were removed using hydrojet. Q-2023 passivating grout with MCI®-2006 NS was applied to the exposed rebar, followed by Q-2039 Repair Mortar with MCI®-2006 NS. Finally MCI®-2020 was applied to the entire surface.
